Restoration of eutrophicated lakes around the city of Växjö

Andreas Hedrén, Växjö Municipality

River Basin Mörrumsån and the small River Basin "Växjö lakes"

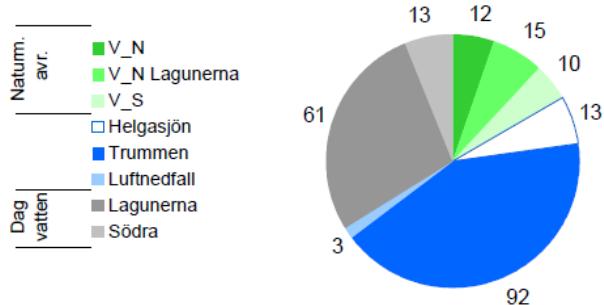
P-sources:

2011-2014: Profound investigations

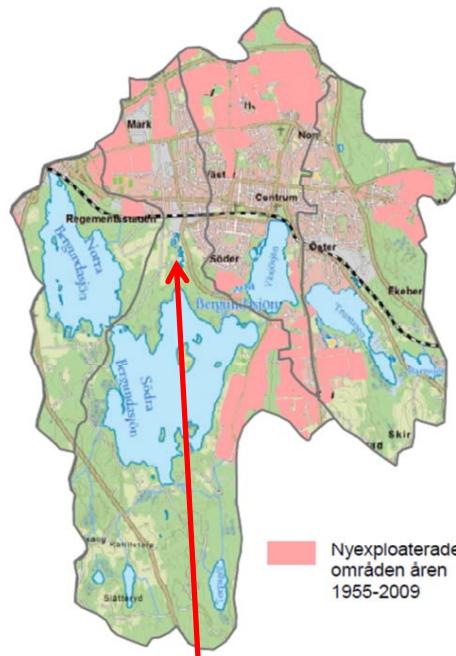
External sources: Storm water, natural runoff and wastewater. minimize effects of recent and previous activities

Already 85% P-reduction!
➤ Vegetation
➤ Equalized flow

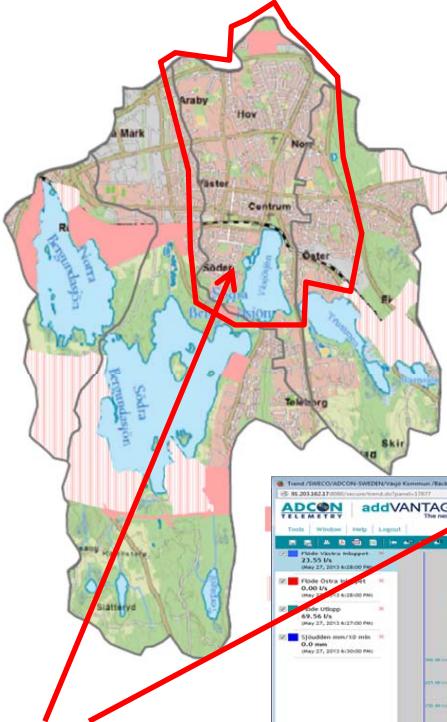
Reduction from
current 70 % to
85% P-reduction.

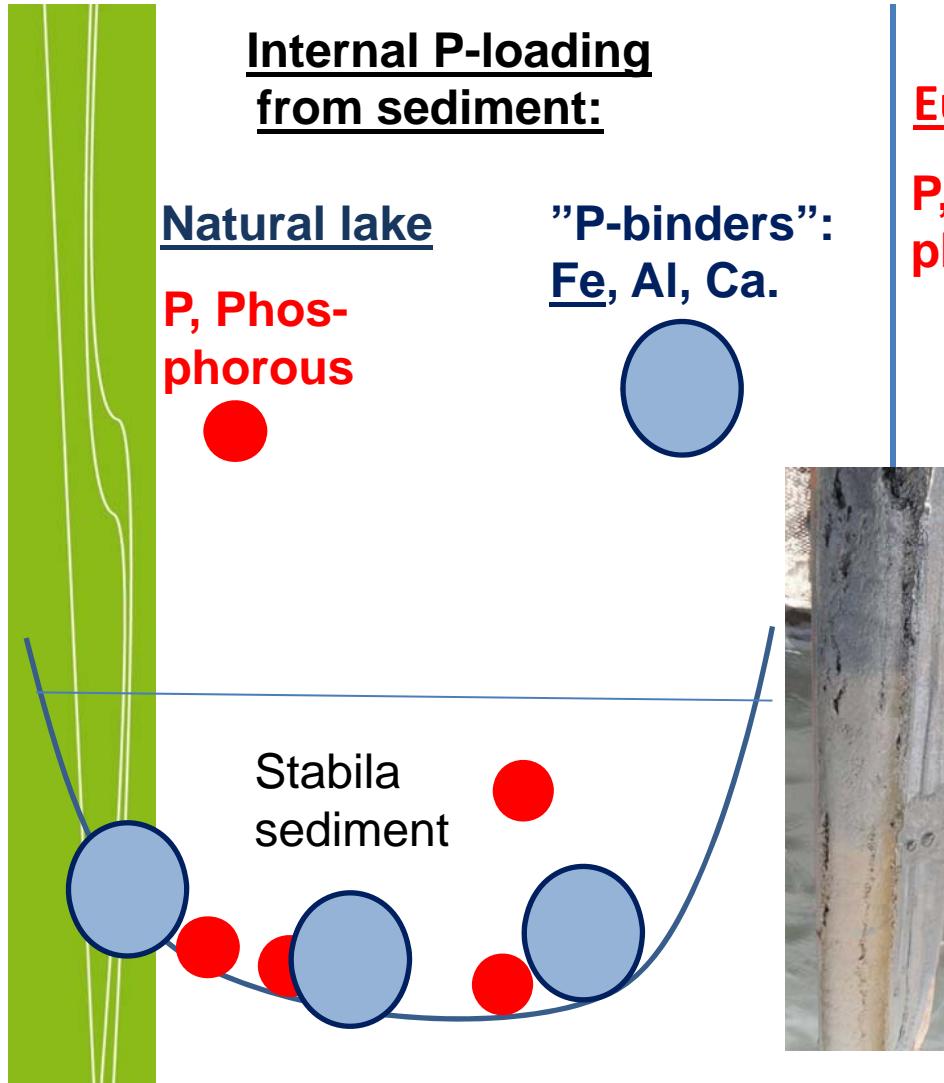
Eutrophic lake

P, Phosphorous

Solution? – Add Aluminium to sediment!

"P-binders": Fe, Al, Ca.

New more dynamic equilibrium: high levels of P in water column, especially during summer

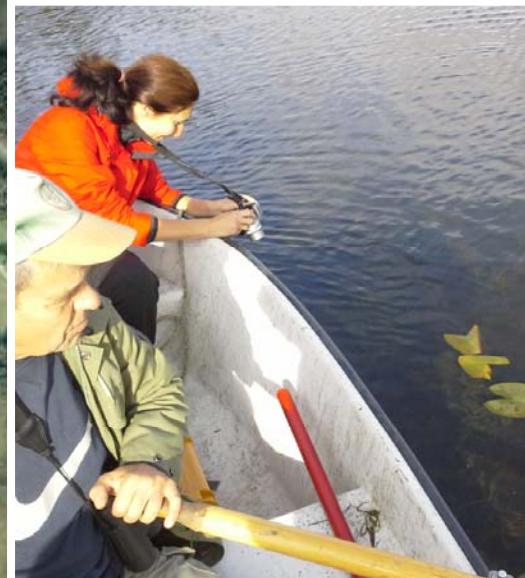
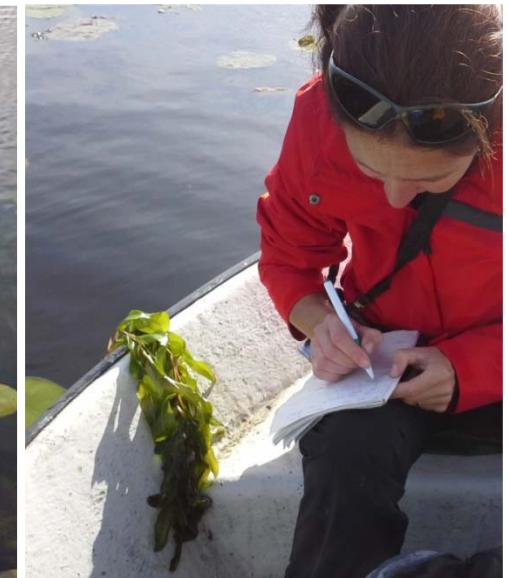
Internal biological processes must be improved!

More plants, zooplankton
and perphyton - **less** algae!
